# TR6 Engine Rebuild

BY TERENCE MCKILLEN

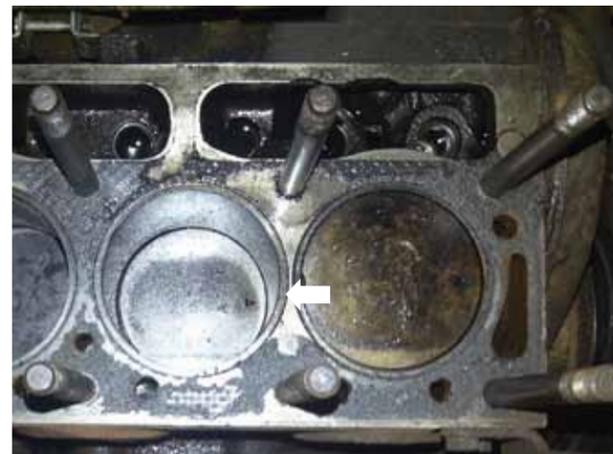
Meanwhile, we dropped out the sump and removed the connecting rod caps to facilitate an inspection of the pistons. It became immediately apparent that we were in to more than just a replacement of piston rings. The #1 piston head had a small nick on the back edge, the #4 piston had a hairline crack on the wall and the rings on the #2 piston were locked solid - coincidentally the same three cylinders with the fouled spark plugs - note to self, spark plugs do more than just provide the spark! There was also evidence of some modest scoring on other pistons and corresponding cylinder sleeves. We also detected noticeable lateral movement of the pistons within the cylinder liners when the connecting rods were manipulated.

The front two-thirds of the Six with arrow showing the nicked #1 piston

rings were right on specification. A set of new pistons and new con rod bearings were sourced and installed without difficulty. It is important to bear in mind the necessity of keeping each con rod cap and bearing together with its corresponding con rod (they are numbered from 1 to 6 starting from the front of the engine), ensuring that the pistons are attached to the con rod gudgeon in the proper orientation ("front" or arrow on the piston head facing forwards) with the con rod sitting on the right hand side and the gaps in the rings alternately spaced and staggered away from the thrust side of the piston.

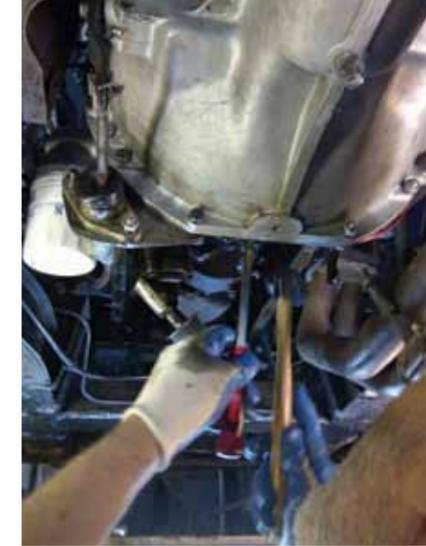
Removing the con rod bearing caps

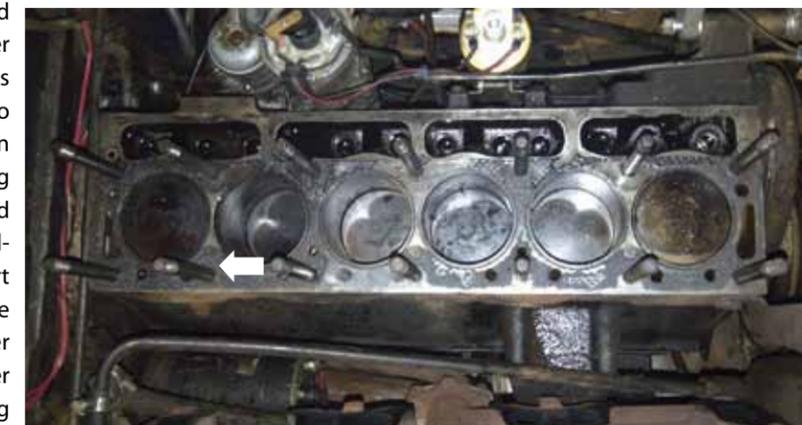
A week later, on June 9, the head was back and torqued down, carefully following the proper sequence of tightening of the cylinder head retaining nuts. Two of the 14 cylinder head studs are slightly longer than the others. This is not referred to in the Bentley Manual or the BLMC Workshop Manual, but the Haynes Manual suggests that they should be utilised as the two rear most studs on the right hand side of the engine block.

The two longer head studs are at the rear right side
